FULL RESERVE STUDY

Tuscan Village at Lakeway Lofts

Lakeway, Texas
November 24, 2020

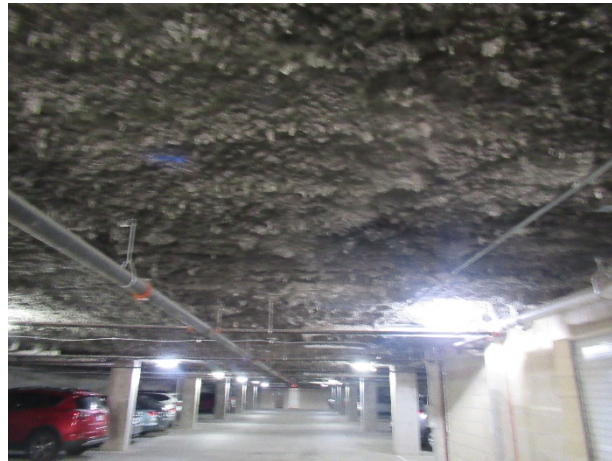
Spray foam insulation at the garage

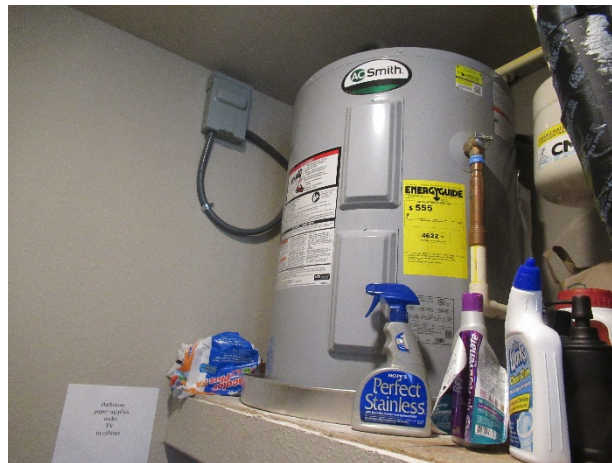
Water heater

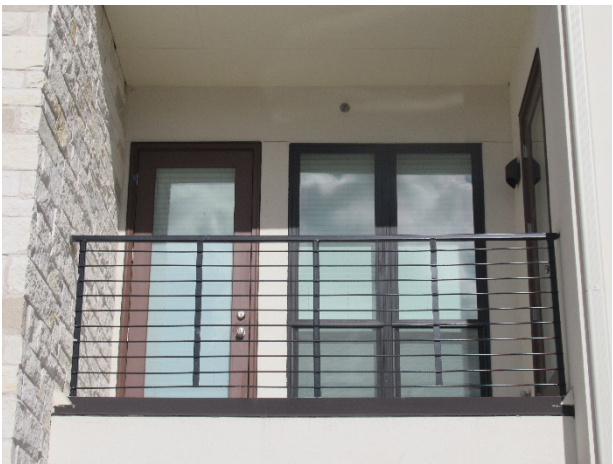
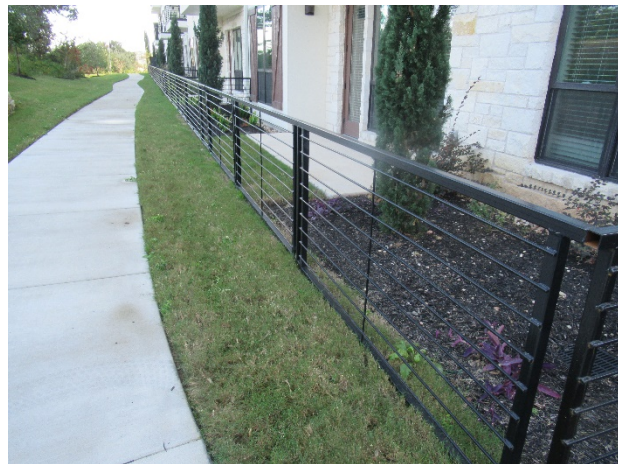
Conditions: Good overall with minor rust evident

Balcony railing

Patio railing

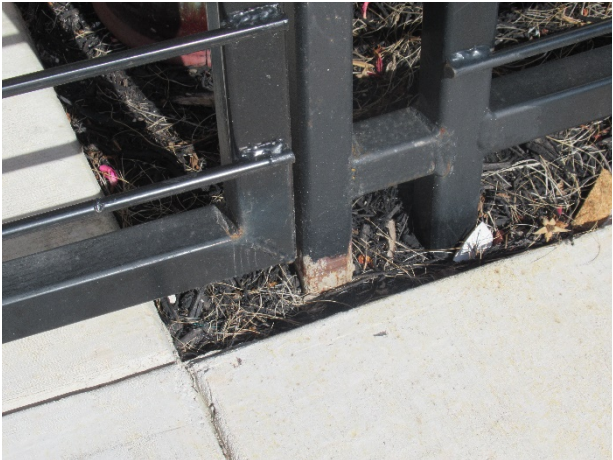
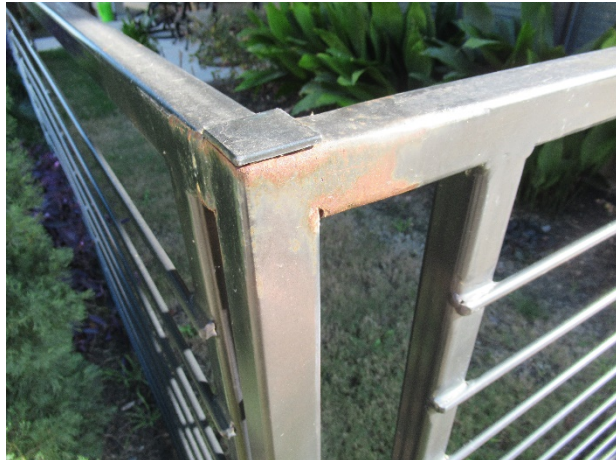
Rust at patio railing

- Paint finishes and repairs to the balcony and patio railings in order to prevent rust and extend useful life

Component Detail Notes: Preparation of the steel before application of the paint finish is critical to maximize the useful life of the finish. The painting contractor should remove all soil, dirt, oil, grease and other foreign materials before application of the paint finish to maximize its useful life. The contractor should also remove paint blisters and rust prior to the paint finish application. We recommend the use of a power wire brush, scraper and/or sander as effective means of removal. The Association should require the application of a primer on bare material. The primer for material surfaces should include a rust inhibitor for added protection.

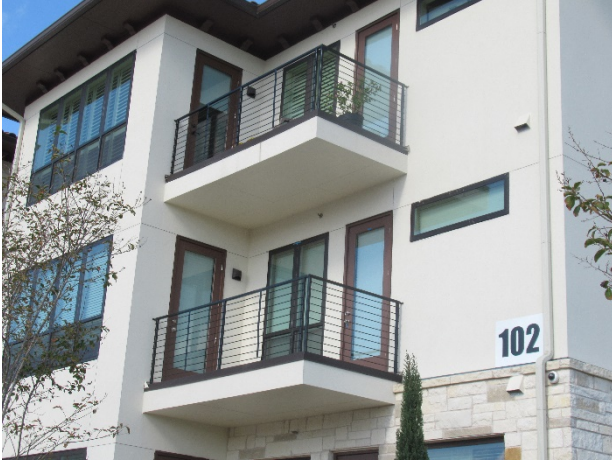
Condition: Good to fair overall with isolated soffit damage and stain at balcony flashing evident

Balconies

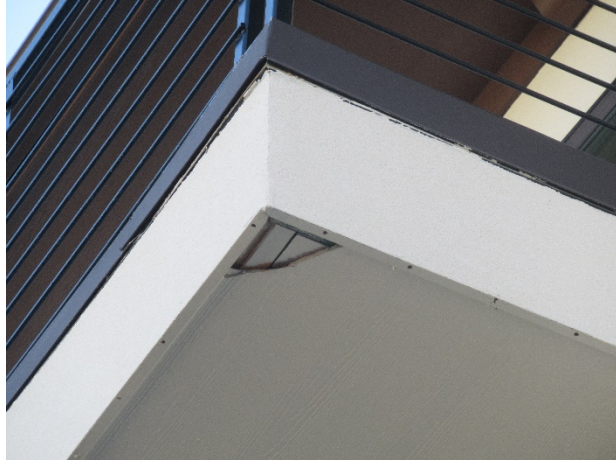
Damaged soffit

- Removal and replacement of up to eight percent (8%) of the thinset concrete topping and underlying waterproof membrane
- Partial replacement of up to eight percent (8%) of wood components
- Repairs of adjacent wall surfaces
- Repairs to the railings as necessary
- Replacement of perimeter sealants as needed

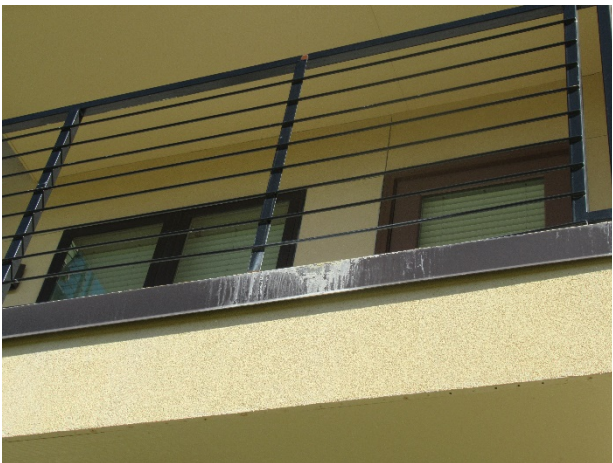
Stain at balcony flashing

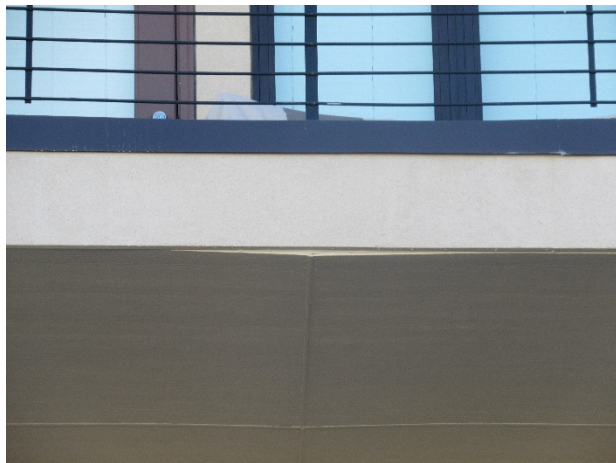
Minor soffit damage

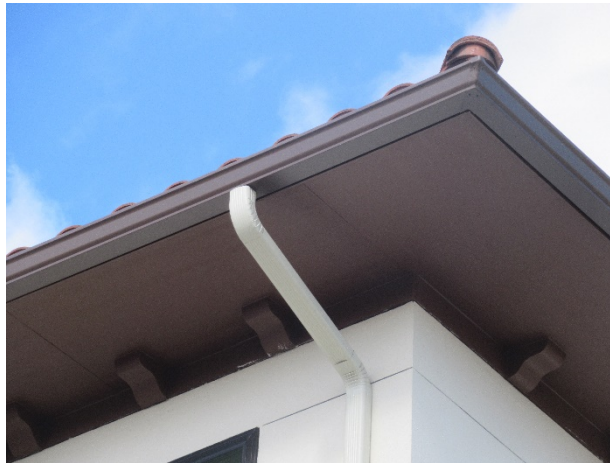
Condition: Good overall

Gutter and downspout assembly

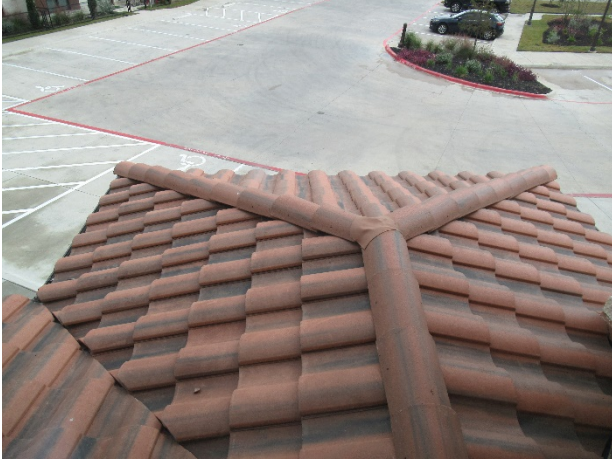
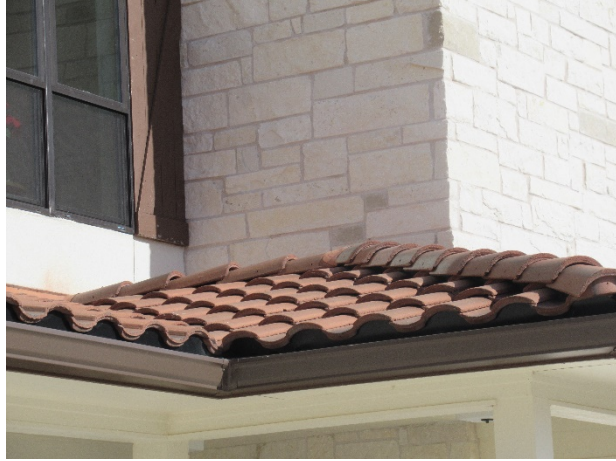
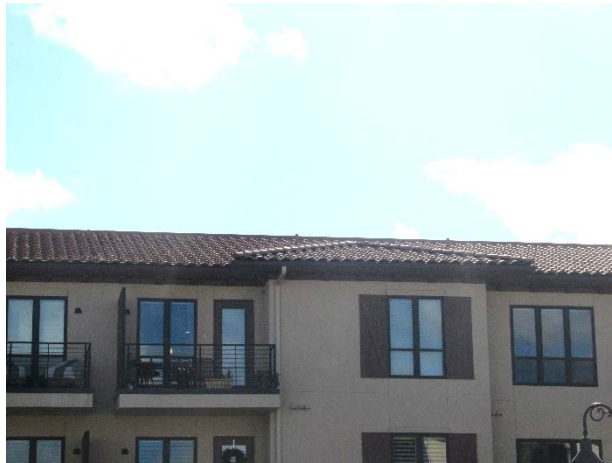
Condition: Good overall based on our visual inspection from the ground. Management and the Board does not report any leaks or recent repairs.

Concrete tile roof overview

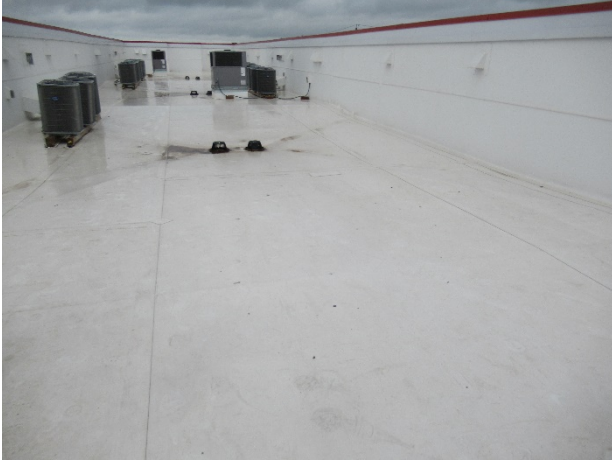
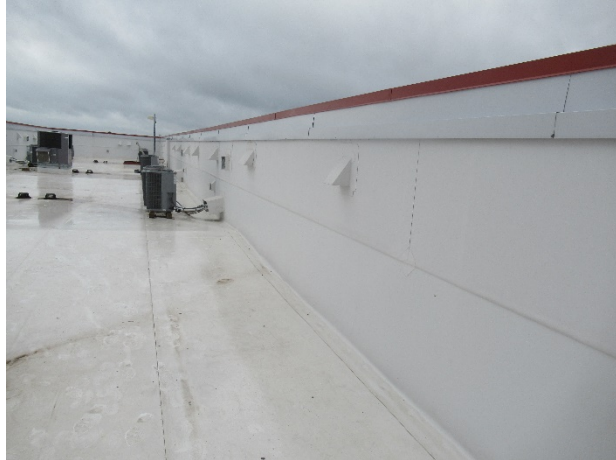
Condition: Good overall with discoloration evident

Thermoplastic roof overview

Roof and flashing overview

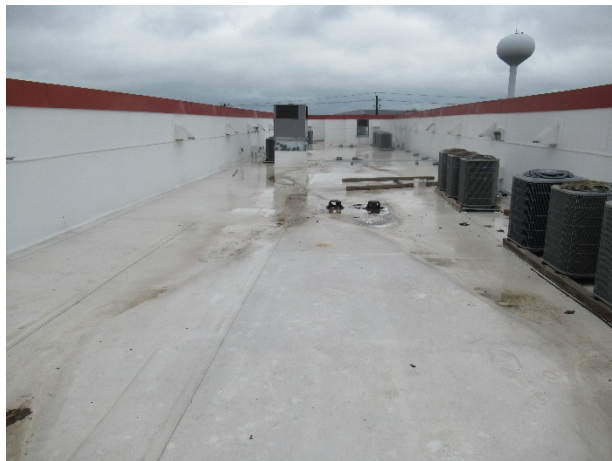
Discoloration at roof

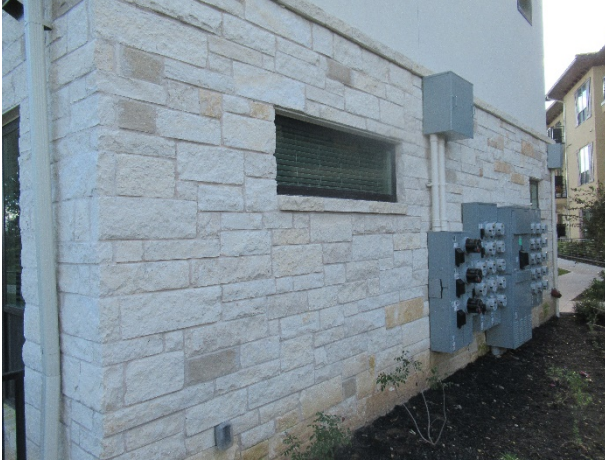
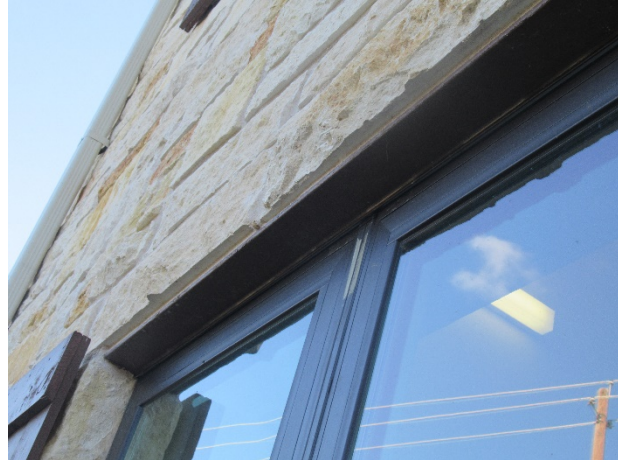
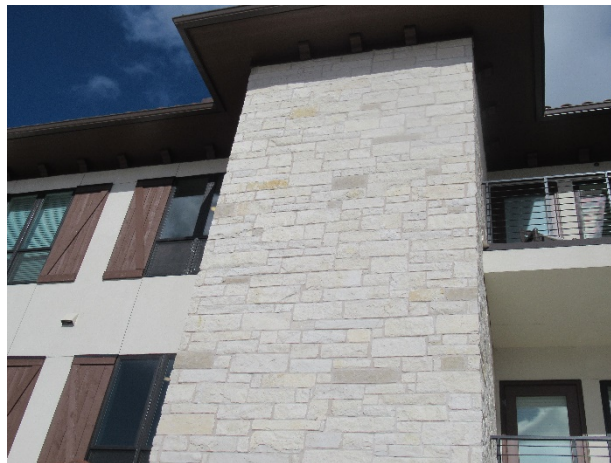
Condition: Good overall

Exterior masonry wall overview

Lintel overview

Exterior masonry wall in good condition

We recommend an inspection, repair and replacement of the steel lintels. Lintels are structural supports or beams above windows and doors. Fatigued lintels also allow the direct penetration of storm water into the wall assembly. These inspections should locate areas of rust on the lintels and cracks or other structural damage to the walls around lintels. The contractor should remove any areas of rust, prime and paint these lintels. Paint protects and maximizes the remaining useful life of the lintels and therefore the exterior wall systems. Structural damage can eventually lead to costly replacements of lintels and surrounding wall systems. The following diagram details a typical metal lintel and weep system and may not reflect the actual configuration at Tuscan Village at Lakeway Lofts:

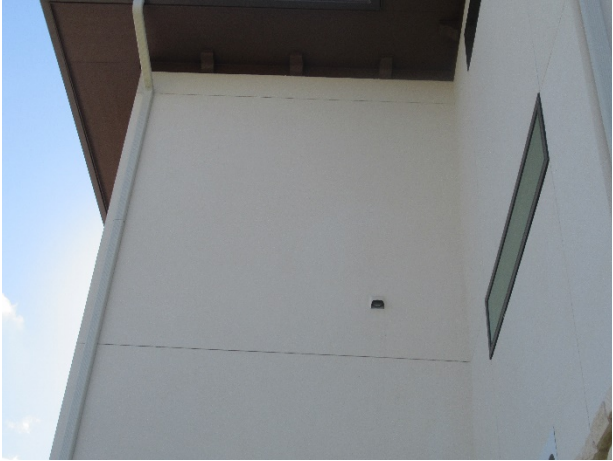
Condition: Good overall with minor stucco damage, discoloration and staining evident

Exterior stucco finish

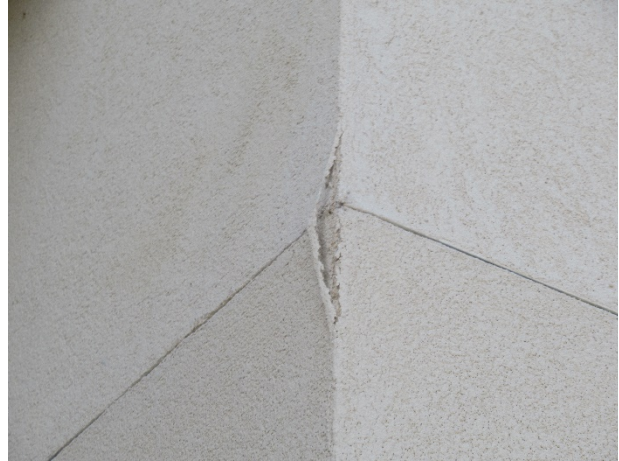
Minor stucco damage

Correct and complete preparation of the surface before application of the paint finish maximizes the useful life of the paint finish and surface. The contractor should remove all loose, peeled or blistered paint before application of the new paint finish. The contractor should then power wash the surface to remove all dirt and biological growth. Water-soluble cleaners that will not attack Portland cement are acceptable for removing stains.

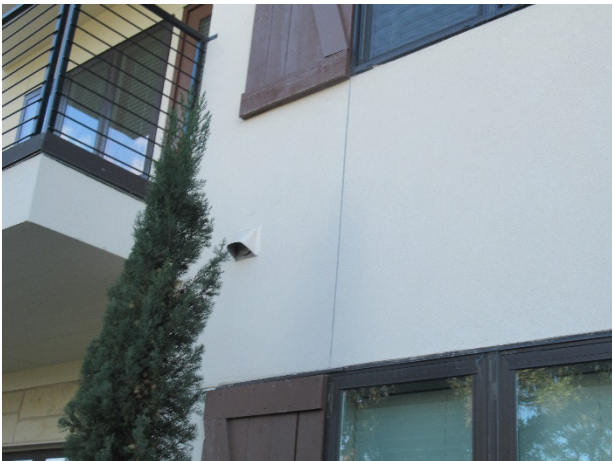
Minor discoloration

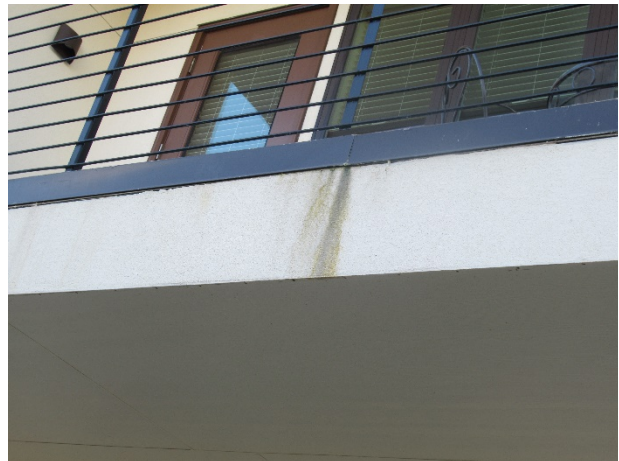
Staining at stucco finish

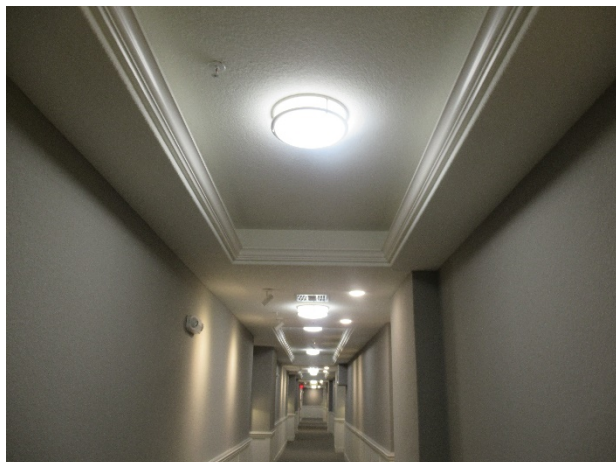
Paint finishes in good condition

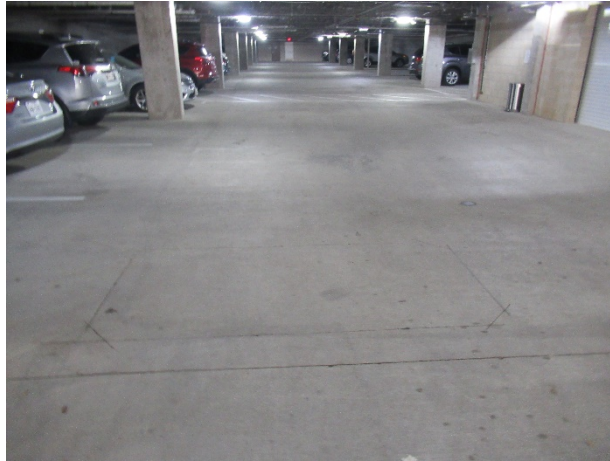
Condition: Good overall

On-grade concrete at garage
